Samsung EVO 840 - 250 GB SSD

Repair Manual

Current version: 27.04.2018

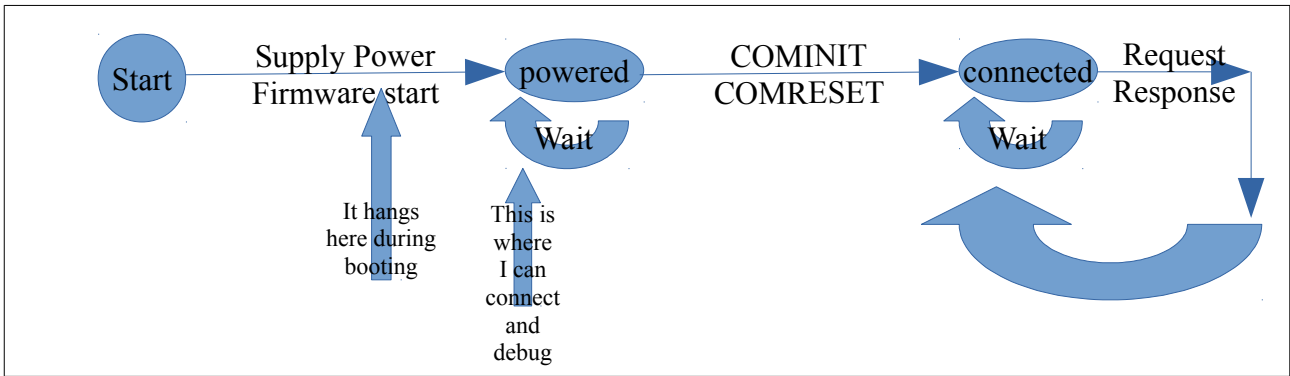
As soon as the SSD is connected with power, it starts the firmware, when the initialization is done, it starts waiting for a connection with the HOST computer (a small loop that checks the status register 0x200000AC bits for the COMINIT signal), when that signal is given, it continues by configuring the SATA PHY for the connection, and then it starts waiting for Requests from the computer.

The problem with my SSD is that the Firmware start seems to initialize the SATA PHY properly in the beginning, but it then somehow deviates from the correct program flow and does not get to the “powered wait” loop. If the firmware would get to the “powered wait” loop, it could get the COMINIT signal from the SATA PHY and could continue properly.

Later on, I found out that the reason is a problem in the flash channels that is detected by the firmware, and therefore it stops starting and does not enable the SATA interface.
