Samsung EVO 840 - 250 GB SSD

Repair Manual

Current version: 27.04.2018

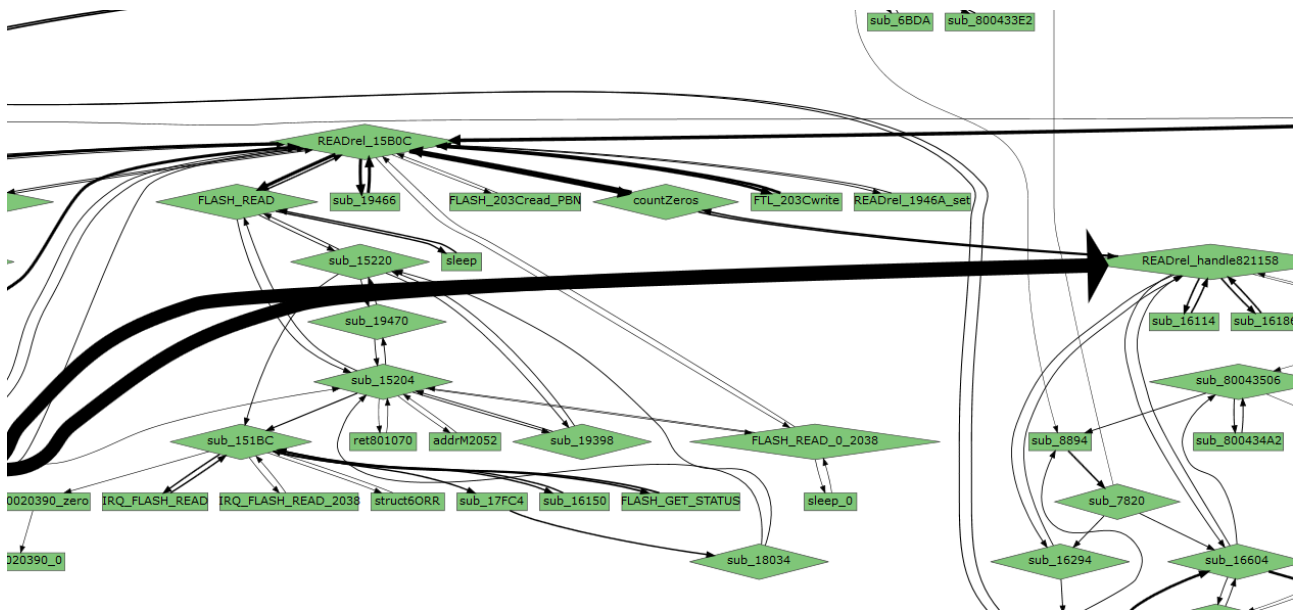
I used a commercial tool PQM for business process analysis to visualize the flows that I traced between the various functions, this helped a lot to understand what is actually going on in the firmware. The following screenshot shows read requests that are handled on mex2:

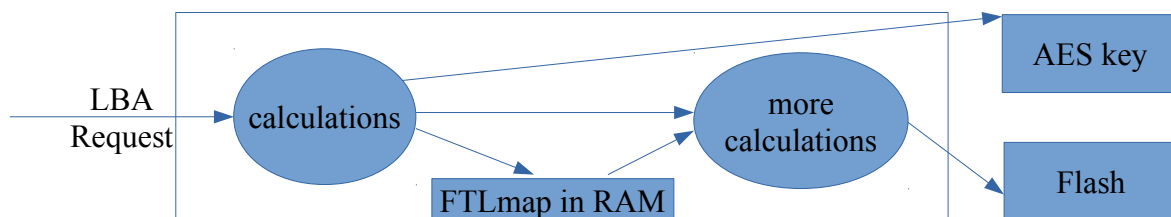
In a simplified diagram the FTL mapping looks like this:

The FTL takes the LBA number (which 512-Byte block should be read/written to/from the SSD), and calculates the address in the FTLmap. The FTLmap contains the wear-leveling mapping for every 4KB page of the SSD, so every 4KB can be anywhere on the SSD. Every entry in the FTLmap is 64 Bits / 8 Bytes, so the FTLmap for a 250 GB SSD (4883997168 512-byte blocks) takes up 466 MB, which is taking up most of the RAM that the SSD has (512 MB). The address from the FTLmap together with some more bits from the original LBA request is then calculated into the parameters for accessing the right page of Flash. The AES key is directly derived from the LBA, it does not depend on the data in the FTLmap.

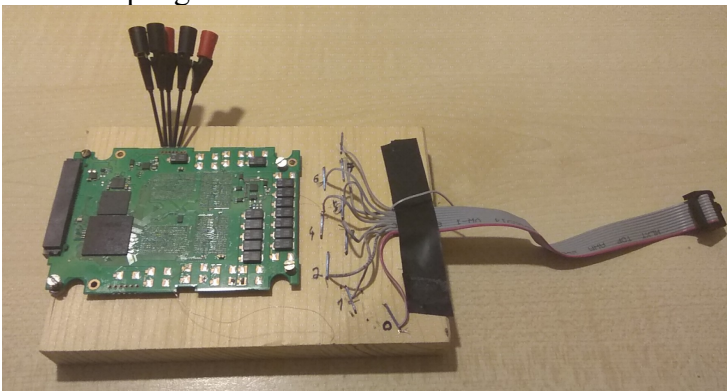
Since the board of the SSD bent slightly on pressure, I built a wooden fixture and screwed the SSD with spacers on the board. Then I got some Micro-Probes that I could use to interface with the JTAG pins. Then I took a 10-Pin cable, removed the connector and spliced it up on one end, and used a staple gun to fixate the ends on the wood.

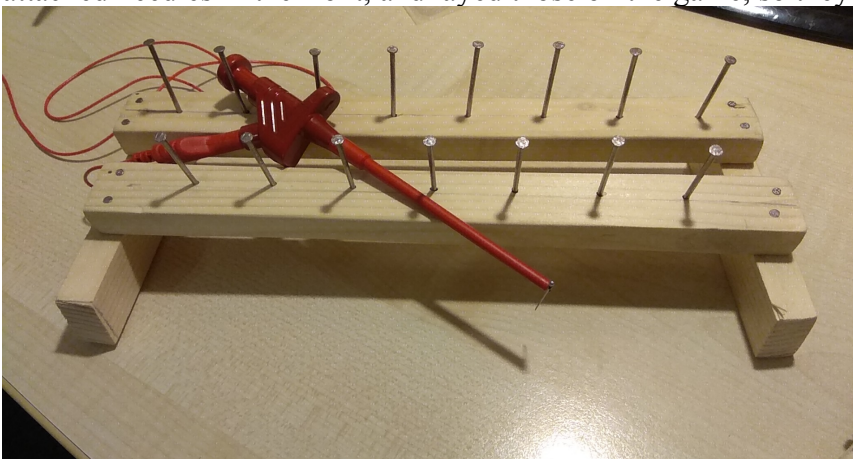
Then I found an old wooden game of my children. I took flexible test clip pinch grippers and attached needles in the front, and layed those on the game, so they became my flying probes.

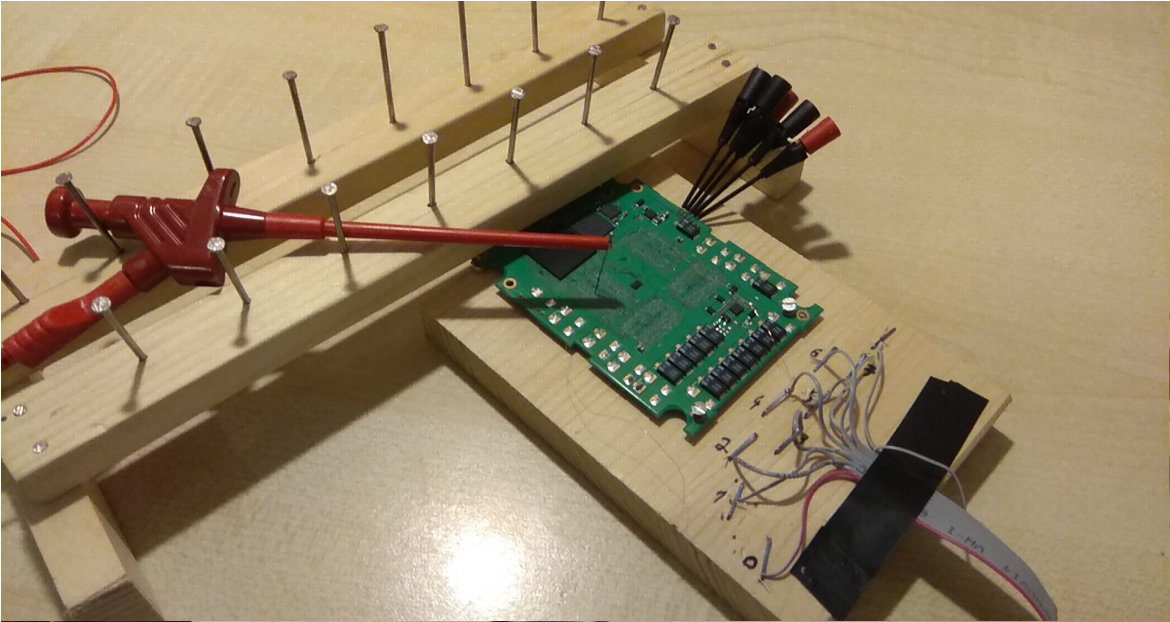
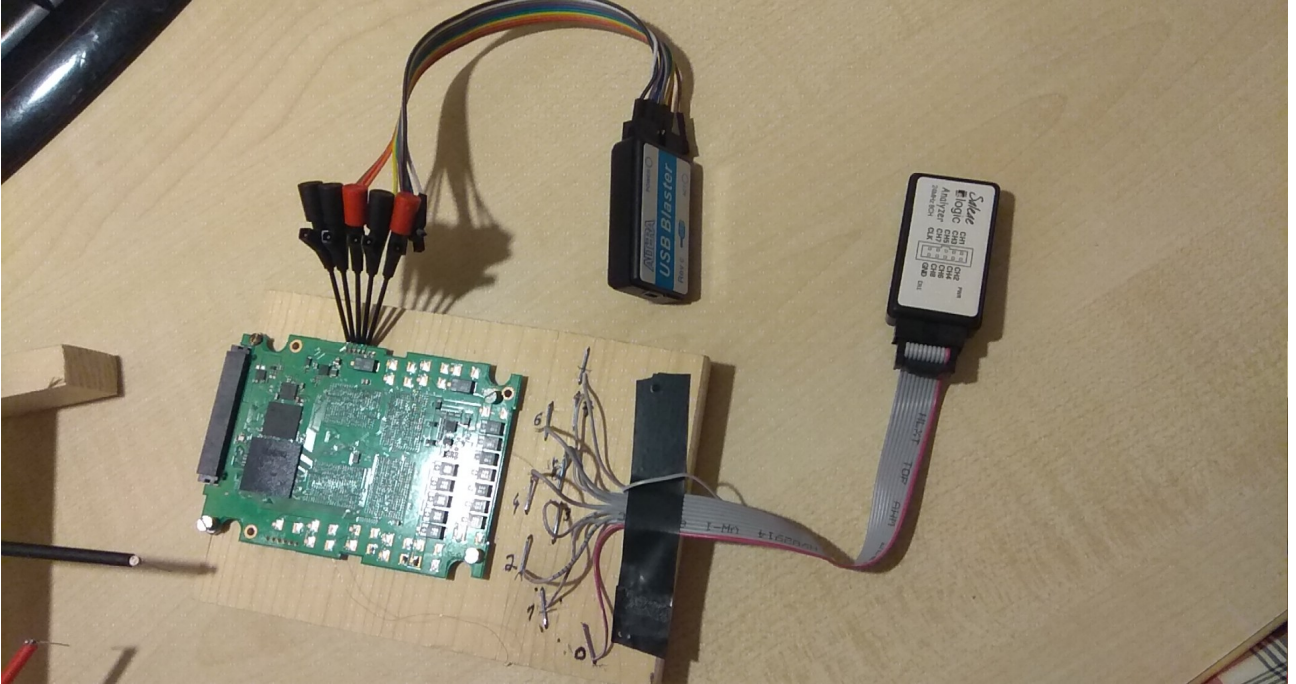
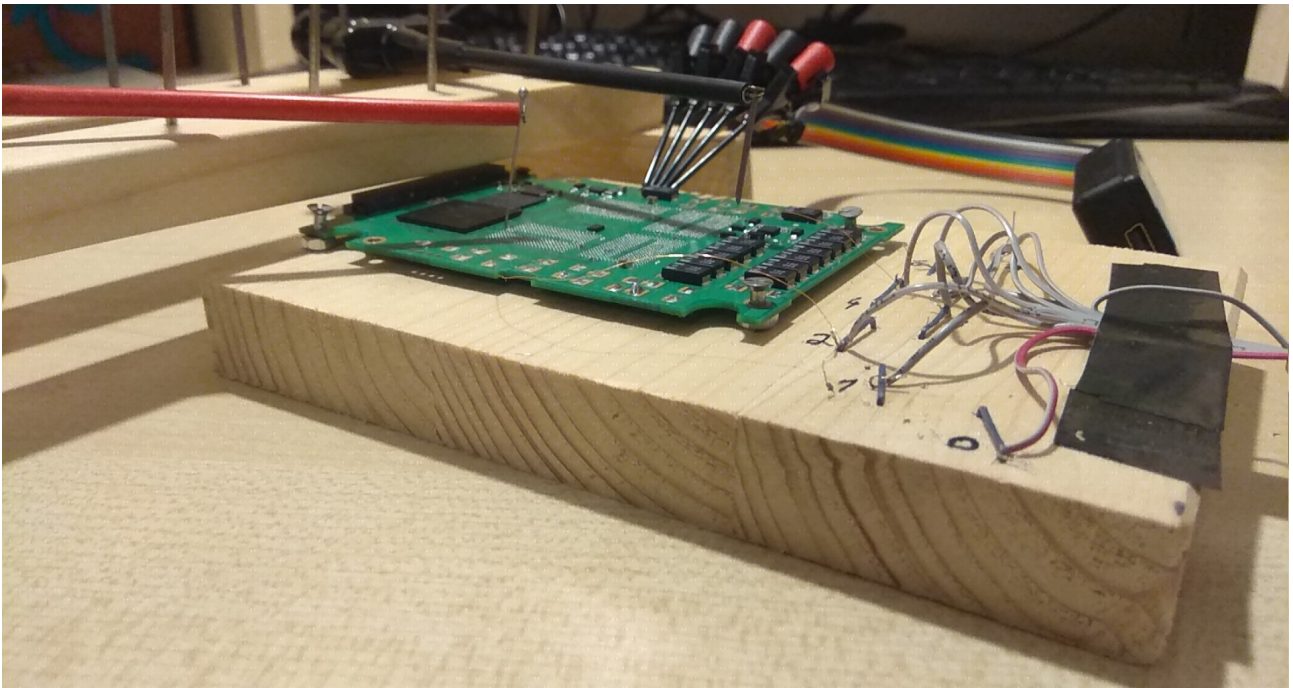
Then I combined both the fixture and the flying probes, and I was able to solder several copper wires permanently and also to directly measure individual BGA balls on demand.
